**DETERMINANTS OF HAND PUMP BOREHOLE PERFORMANCE AND  
EFFICIENCY IN RURAL AREAS OF UGANDA:A CASE STUDY OF KIBUKU  
DISTRICT**

**A DISSERTATION SUBMITTED TO THE FACULTY OF ENGINEERING, DESIGN AND  
TECHNOLOGY IN PARTIAL FULFILLMENT OF THE REQUIREMENTS FOR THE DEGREE  
OF THE MASTER OF SCIENCE IN WATER AND SANITATION OF UGANDA CHRISTIAN  
UNIVERSITY**

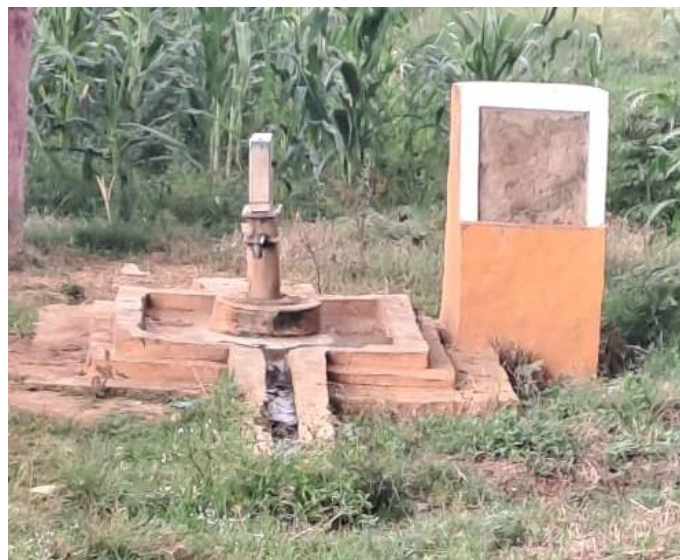
**Figure 4.1: Partially functional borehole**

Table 2, shows an assessment of the operational status of boreholes in Kibuku District revealed that out of the 110 sampled water points, the majority (65.5%) were classified as fully functional. These boreholes consistently delivered water with minimal interruptions, suggesting proper maintenance and infrastructure reliability. Partially functional boreholes constituted 28.2% of the total, indicating intermittent operation often due to mechanical wear, inadequate community management as shown in figure 4.1, or seasonal fluctuations in groundwater levels. A smaller fraction, 6.3%, were found to be completely non-functional an example shown in figure 4.2, potentially reflecting long-term neglect, vandalism, or technical failure (Ministry of Water and Environment [MWE], 2021).

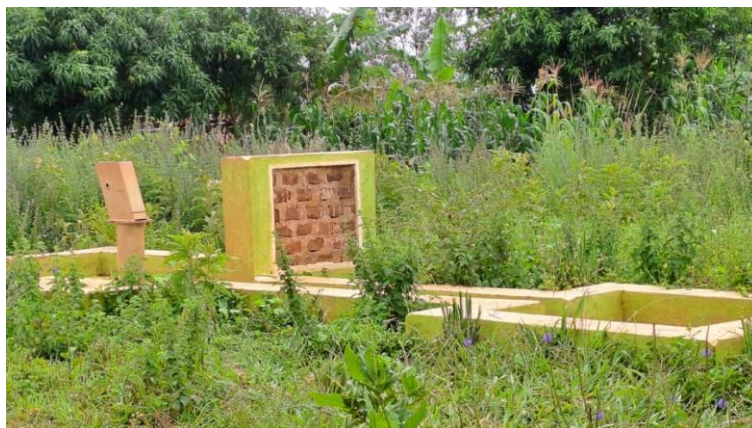
**Figure 4.2 Abandoned, non- functional borehole**
