Research Article

Effect of Unstable Mix under Severe Traffic Loading on Performance of Asphalt Pavements in Tropical Climate

This paper is aimed at assessing the in-service performance of asphalt pavements in tropical climate under severe conditions. The main defect observed on the asphalt pavement was rutting of the asphaltic surfacing, with top-down cracking being experienced on a few sections and not widespread but rather intermittent. Field and laboratory investigations were conducted as well as a review of design and construction records. The defects observed were confined to the wearing course layer of the surfacing with the other underlying layers performing well. Rutting was a result of heavily loaded trucks that moved at very slow speeds due to steep gradients, hence resulting in severely loaded sections. High temperatures due to the warm tropical environment exacerbated the situation and caused the asphalt to flow, hence resulting in rutting and deformation. Also, low air voids in the asphalt mix which were below the recommended design air voids specification aggravated the situation as well as the air voids after refusal density compaction being below the specified cri

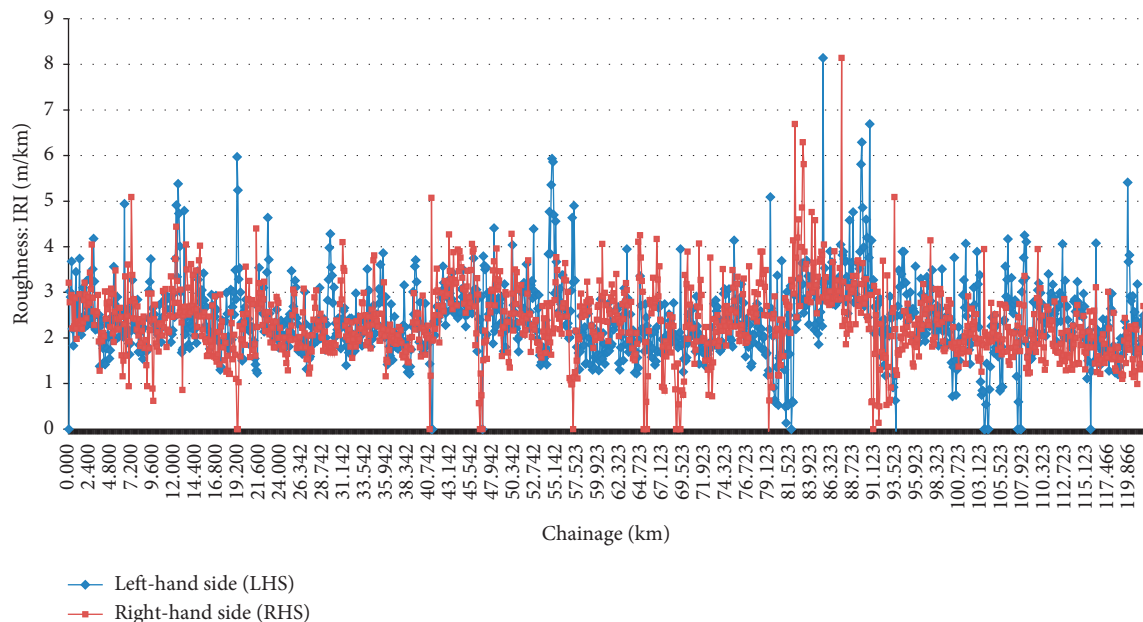
FIGURE 1: Roughness trend along the road.

A roughness survey was conducted on the road in both directions and analysed using the International Roughness Index (IRI). Except for two spots of 100 m each, a big portion of the road generally had IRI less than 6 as shown in Figure 1 which is indicative of a very good road condition. However, for sections that showed obvious rutting (i.e., rut depth ≥ 10 mm) such as S2 and S3, the roughness on the rutted lane was significantly higher than that on the lane with low rutting.

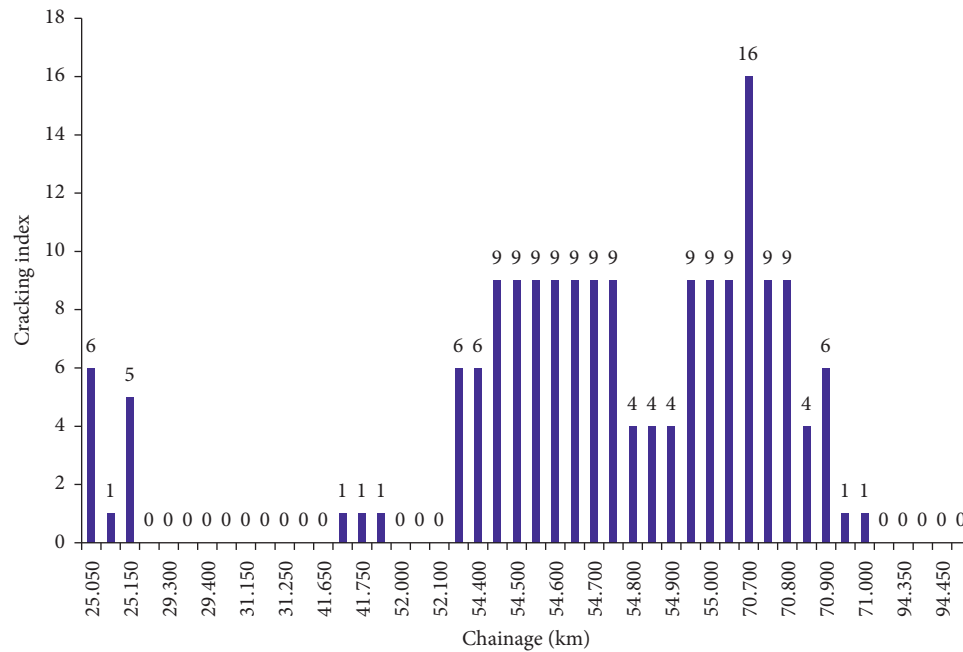
FIGURE 2: Cracking index for the road.

4.2.2. Cracking. Cracks observed on the road were evaluated based on their type, width, intensity, extent, and position. As shown in Figure 2, the cracking index (i.e., a product of crack intensity and extent) generally showed that the road did not experience severe cracking. The highest cracking index value of 16 out of the maximum possible value of 25 was observed in section S4 that generally exhibited longitudinal wheel path cracking and interconnected cracks. The other sections of the road exhibited values below 10 which implied minimal cracking.

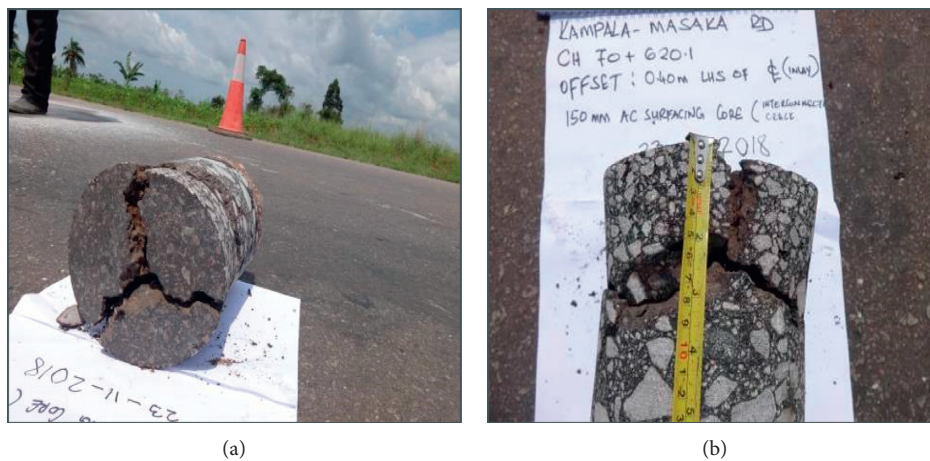
Furthermore, cores extracted from the cracked sections of the road were visually evaluated. As shown in Figure 3, the top-down cracks were observed in the cores but were found to be confined only in the upper portions of the surfacing. This indicated that the cracking observed on road was confined to the surfacing layers and did not propagate through all the layers of the pavement.

FIGURE 3: Interconnected cracks confined to the upper portion of the surfacing.

- (3) Top-down cracking observed on a few cracked sections of the road was determined to have resulted from binder age hardening and embrittlement due to overheating of bitumen during the construction process coupled with heavy truck axles. Since cracking on the road was not widespread but rather intermittent, this supported the premise that bitumen overheating was specific to some few batches during mixing. It is expected that the high traffic loading coupled with high tyre pressures and binder age hardening and embrittlement due to overheating of the bitumen led to the loss of stability in the mix, hence the defects observed on the road.

- (4) Defects observed on the road were confined to the wearing course layer of the surfacing with the other underlying layers performing well. This was confirmed by visual assessment of cracks on cores and test pits excavated in all rutted sections. Also, materials obtained from test pits in both control and failed sections were found to be very similar and within the acceptable specification requirements, implying that failures observed on the road did not originate from the underlying layers below the asphalt surfacing.

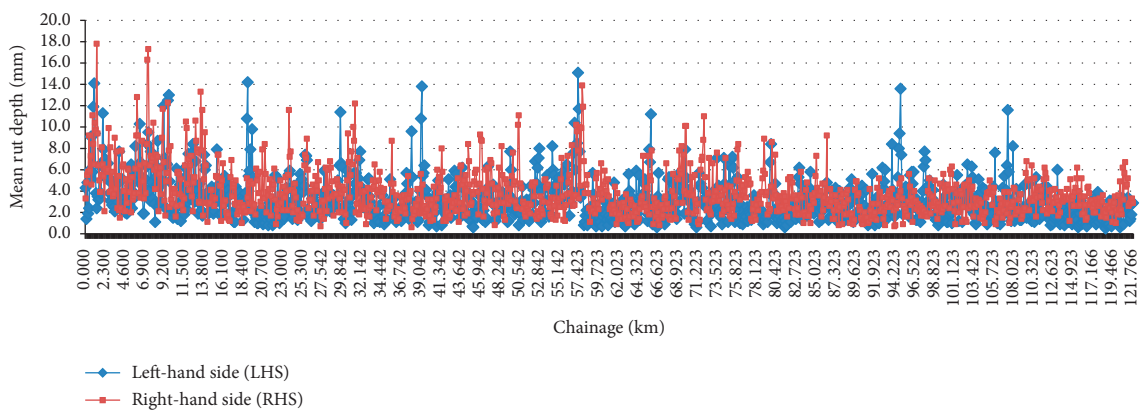
FIGURE 4: Rutting trend along the road.

4.2.3. Rutting. Rut measurements which were carried out in both directions and processed in terms of mm of rut depth indicated that some of the sections had obvious rutting. As shown in Figure 4, highly variable rutting was experienced with occasional peaks indicating variability in performance as a result of either construction or traffic behaviour.

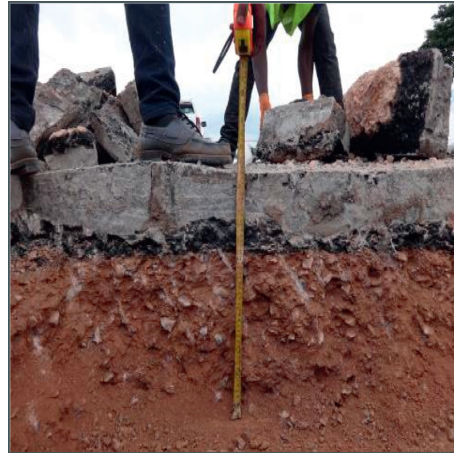
However, test pits excavated in all rutted sections indicated that the rutting was confined to the surfacing and did not extend to the lower pavement layers, as shown in Figure 5. This further confirmed that the failures experienced on the road were mainly confined to the surfacing layers as already indicated by visual observation of cracks on cores. A more detailed understanding of the causes of defects observed in the surface layer is discussed in the results of the laboratory testing section.

FIGURE 5: Test pit at the rutted section of the road.

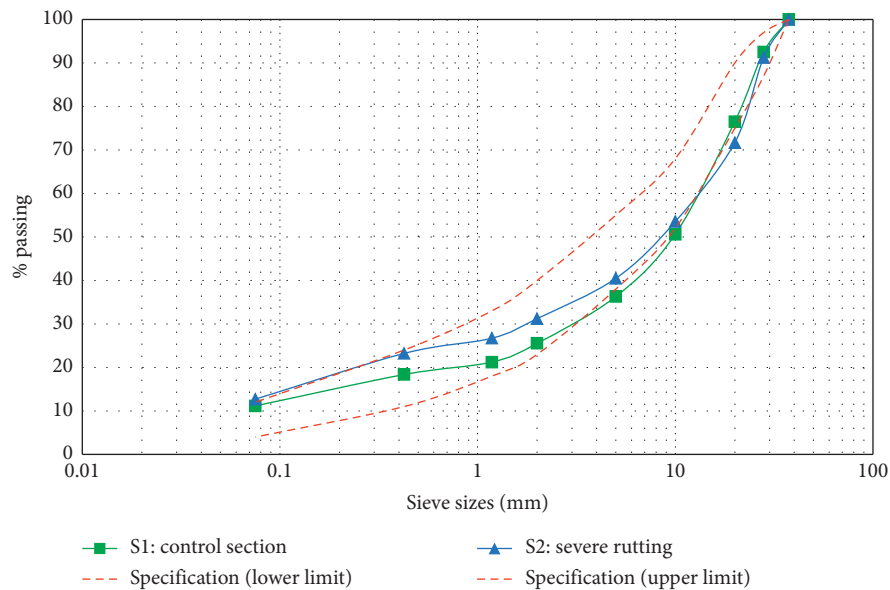
FIGURE 6: Particle size distribution—base course.

4.3.2. Gradation. Figure 6 shows the particle size distribution (PSD) of aggregates (crushed stone) obtained from the base course.

It was generally observed that the grading of the materials obtained from the control and failed sections were all similar and within the specification envelope [32] for the base course. A similar trend was observed for aggregates obtained from the subbase course. Furthermore, Figure 7 shows the PSD of aggregates recovered from the wearing course after extraction of bitumen. Again, the recovered aggregates complied with the control points for Marshall Nominal Asphalt Concrete (AC 14) mixes used in the mix design [32]. The above clearly indicated that aggregate gradation was not responsible for the observed deteriorations on the road.
